Manhole Inspection Summary

Manhole # **S33C__013MH**

Insp Date: **5/14/09 10:52 AM**

Location Address: **200 W FRANKLIN**

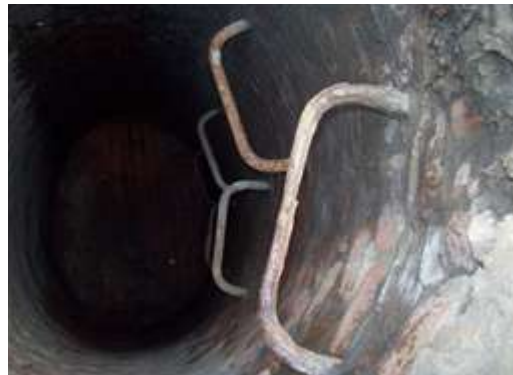
Defect 1

Count: **7** Missing: **0** ☒ **Corroded**

CORRODED STEPS

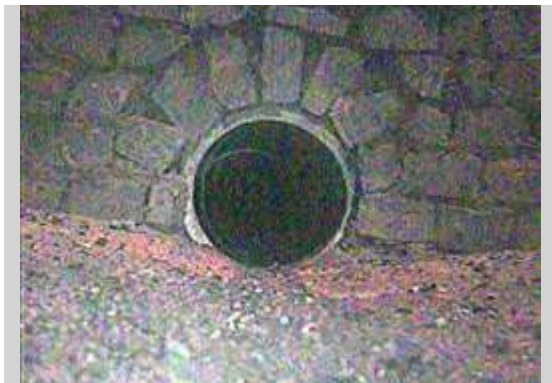
12 O'Clock Outflow

8 in. Circular Gravity Sewer
Pipe Out @ 12 O'Clock

Pipe Material: **PVC** ☐ Pipe Lined

Invert Depth: **11.34** (ft.) Flow Characteristics: **None**

Infiltration: **None** Pipe Seal Cond: **Sound**
